# 2022 Water Quality Forum

Mill Creek Basin

MSD Administration Building  
December 14, 2022

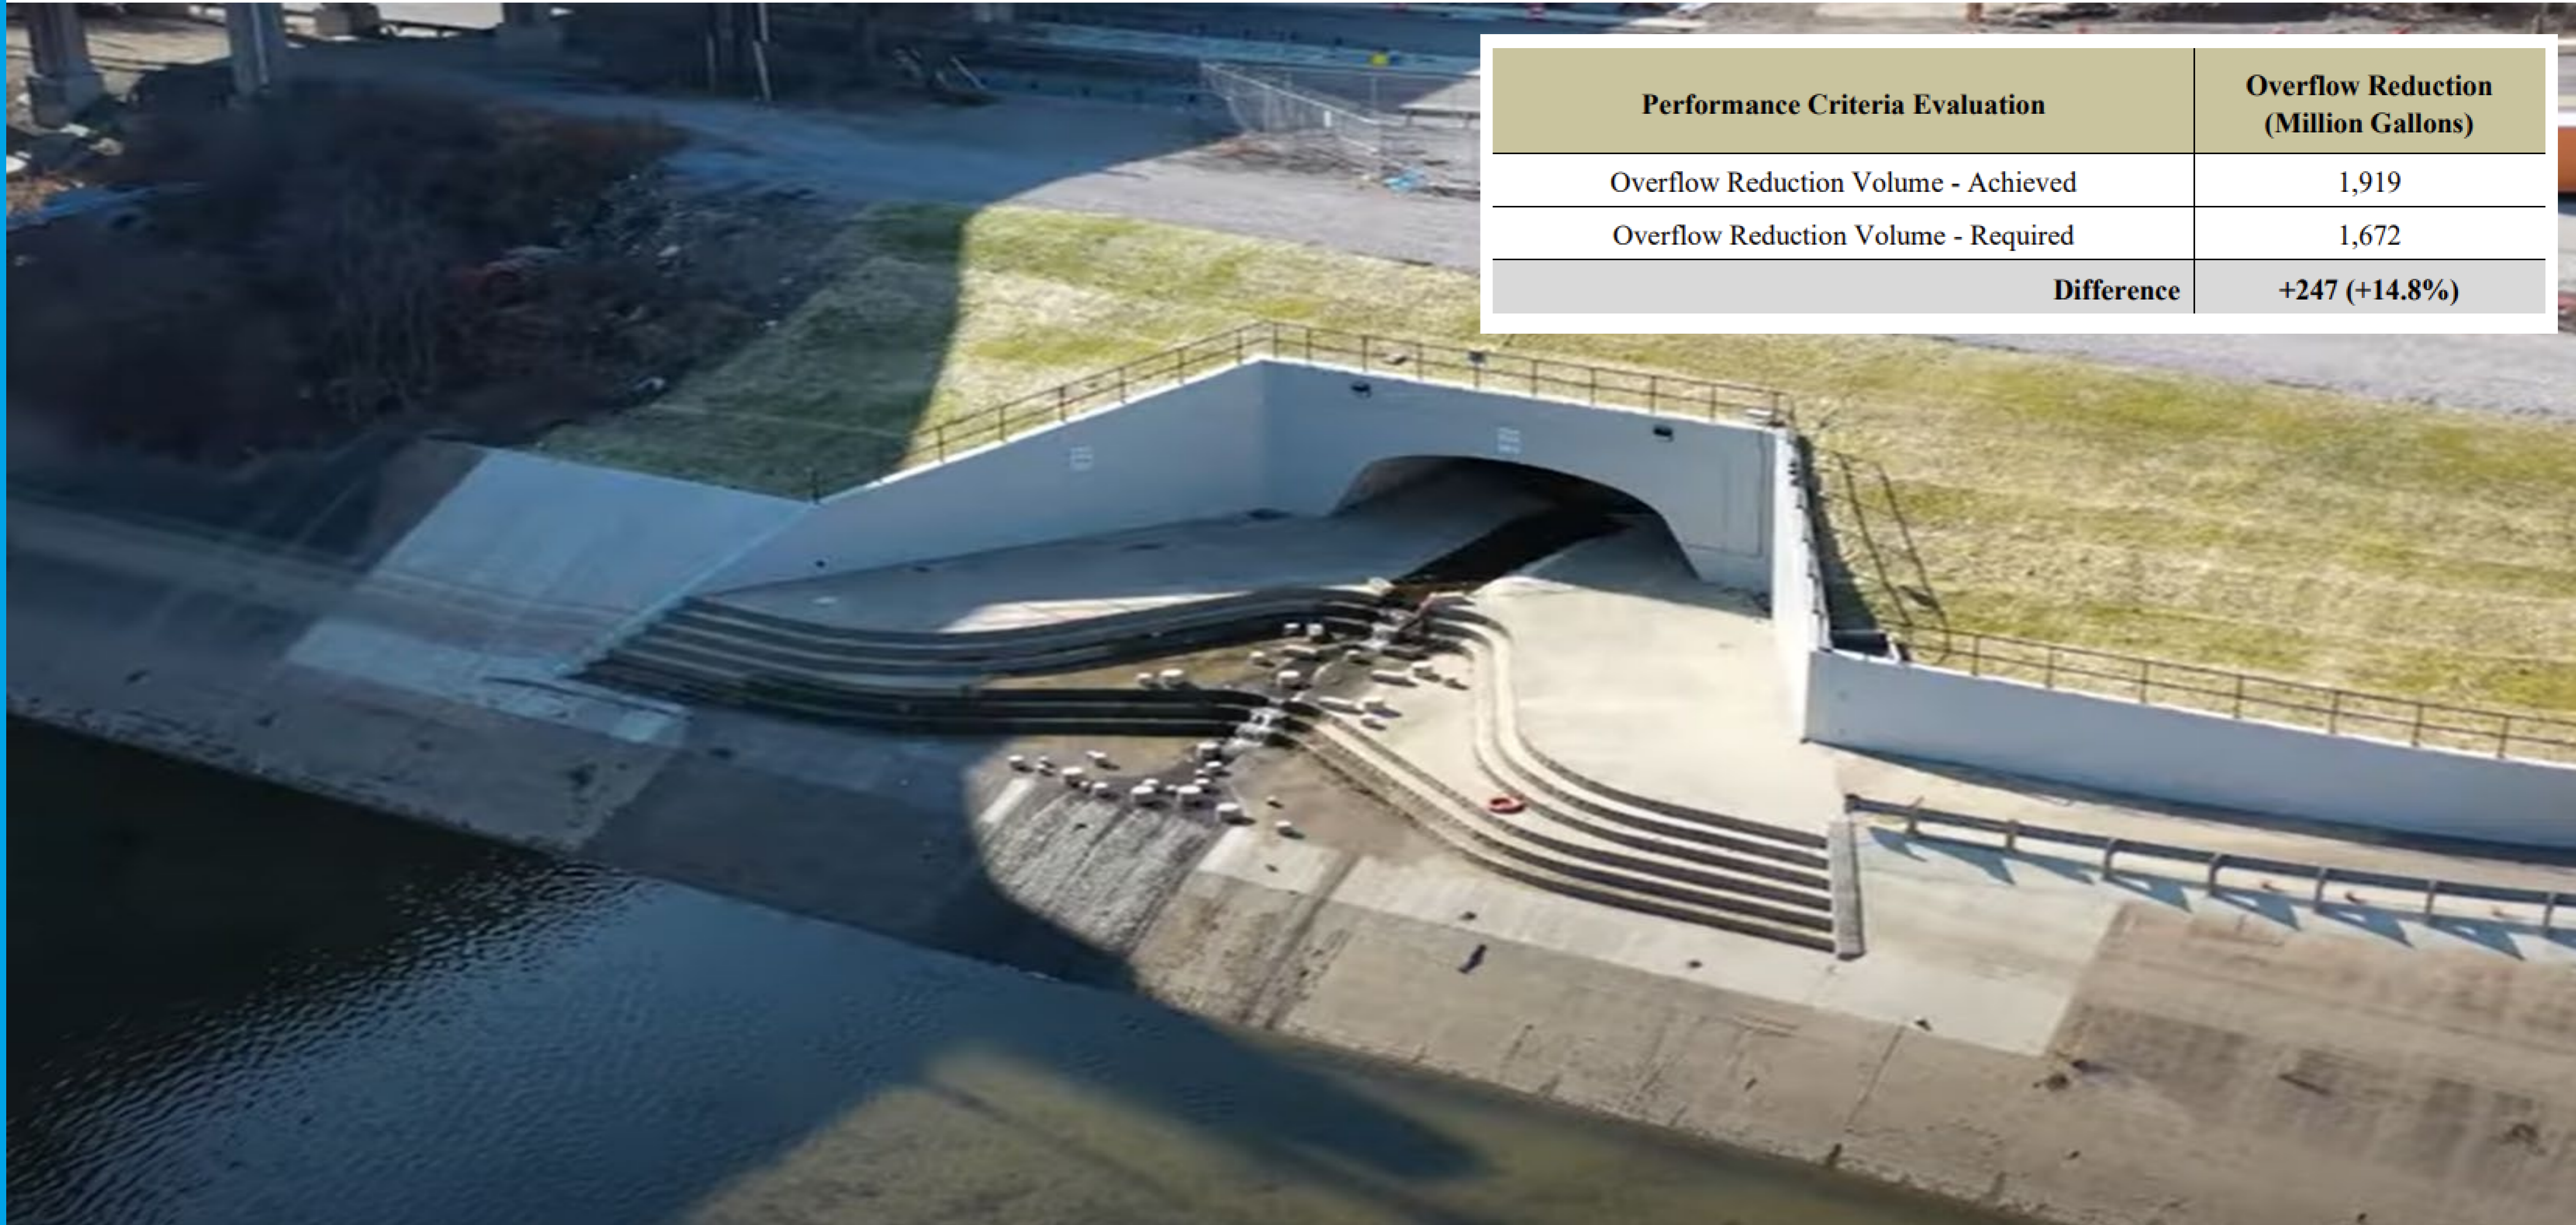
# Validation through *Modeling*

Performance Criteria Evaluation	Overflow Reduction (Million Gallons)
Overflow Reduction Volume - Achieved	1,919
Overflow Reduction Volume - Required	1,672
<b>Difference</b>	<b>+247 (+14.8%)</b>

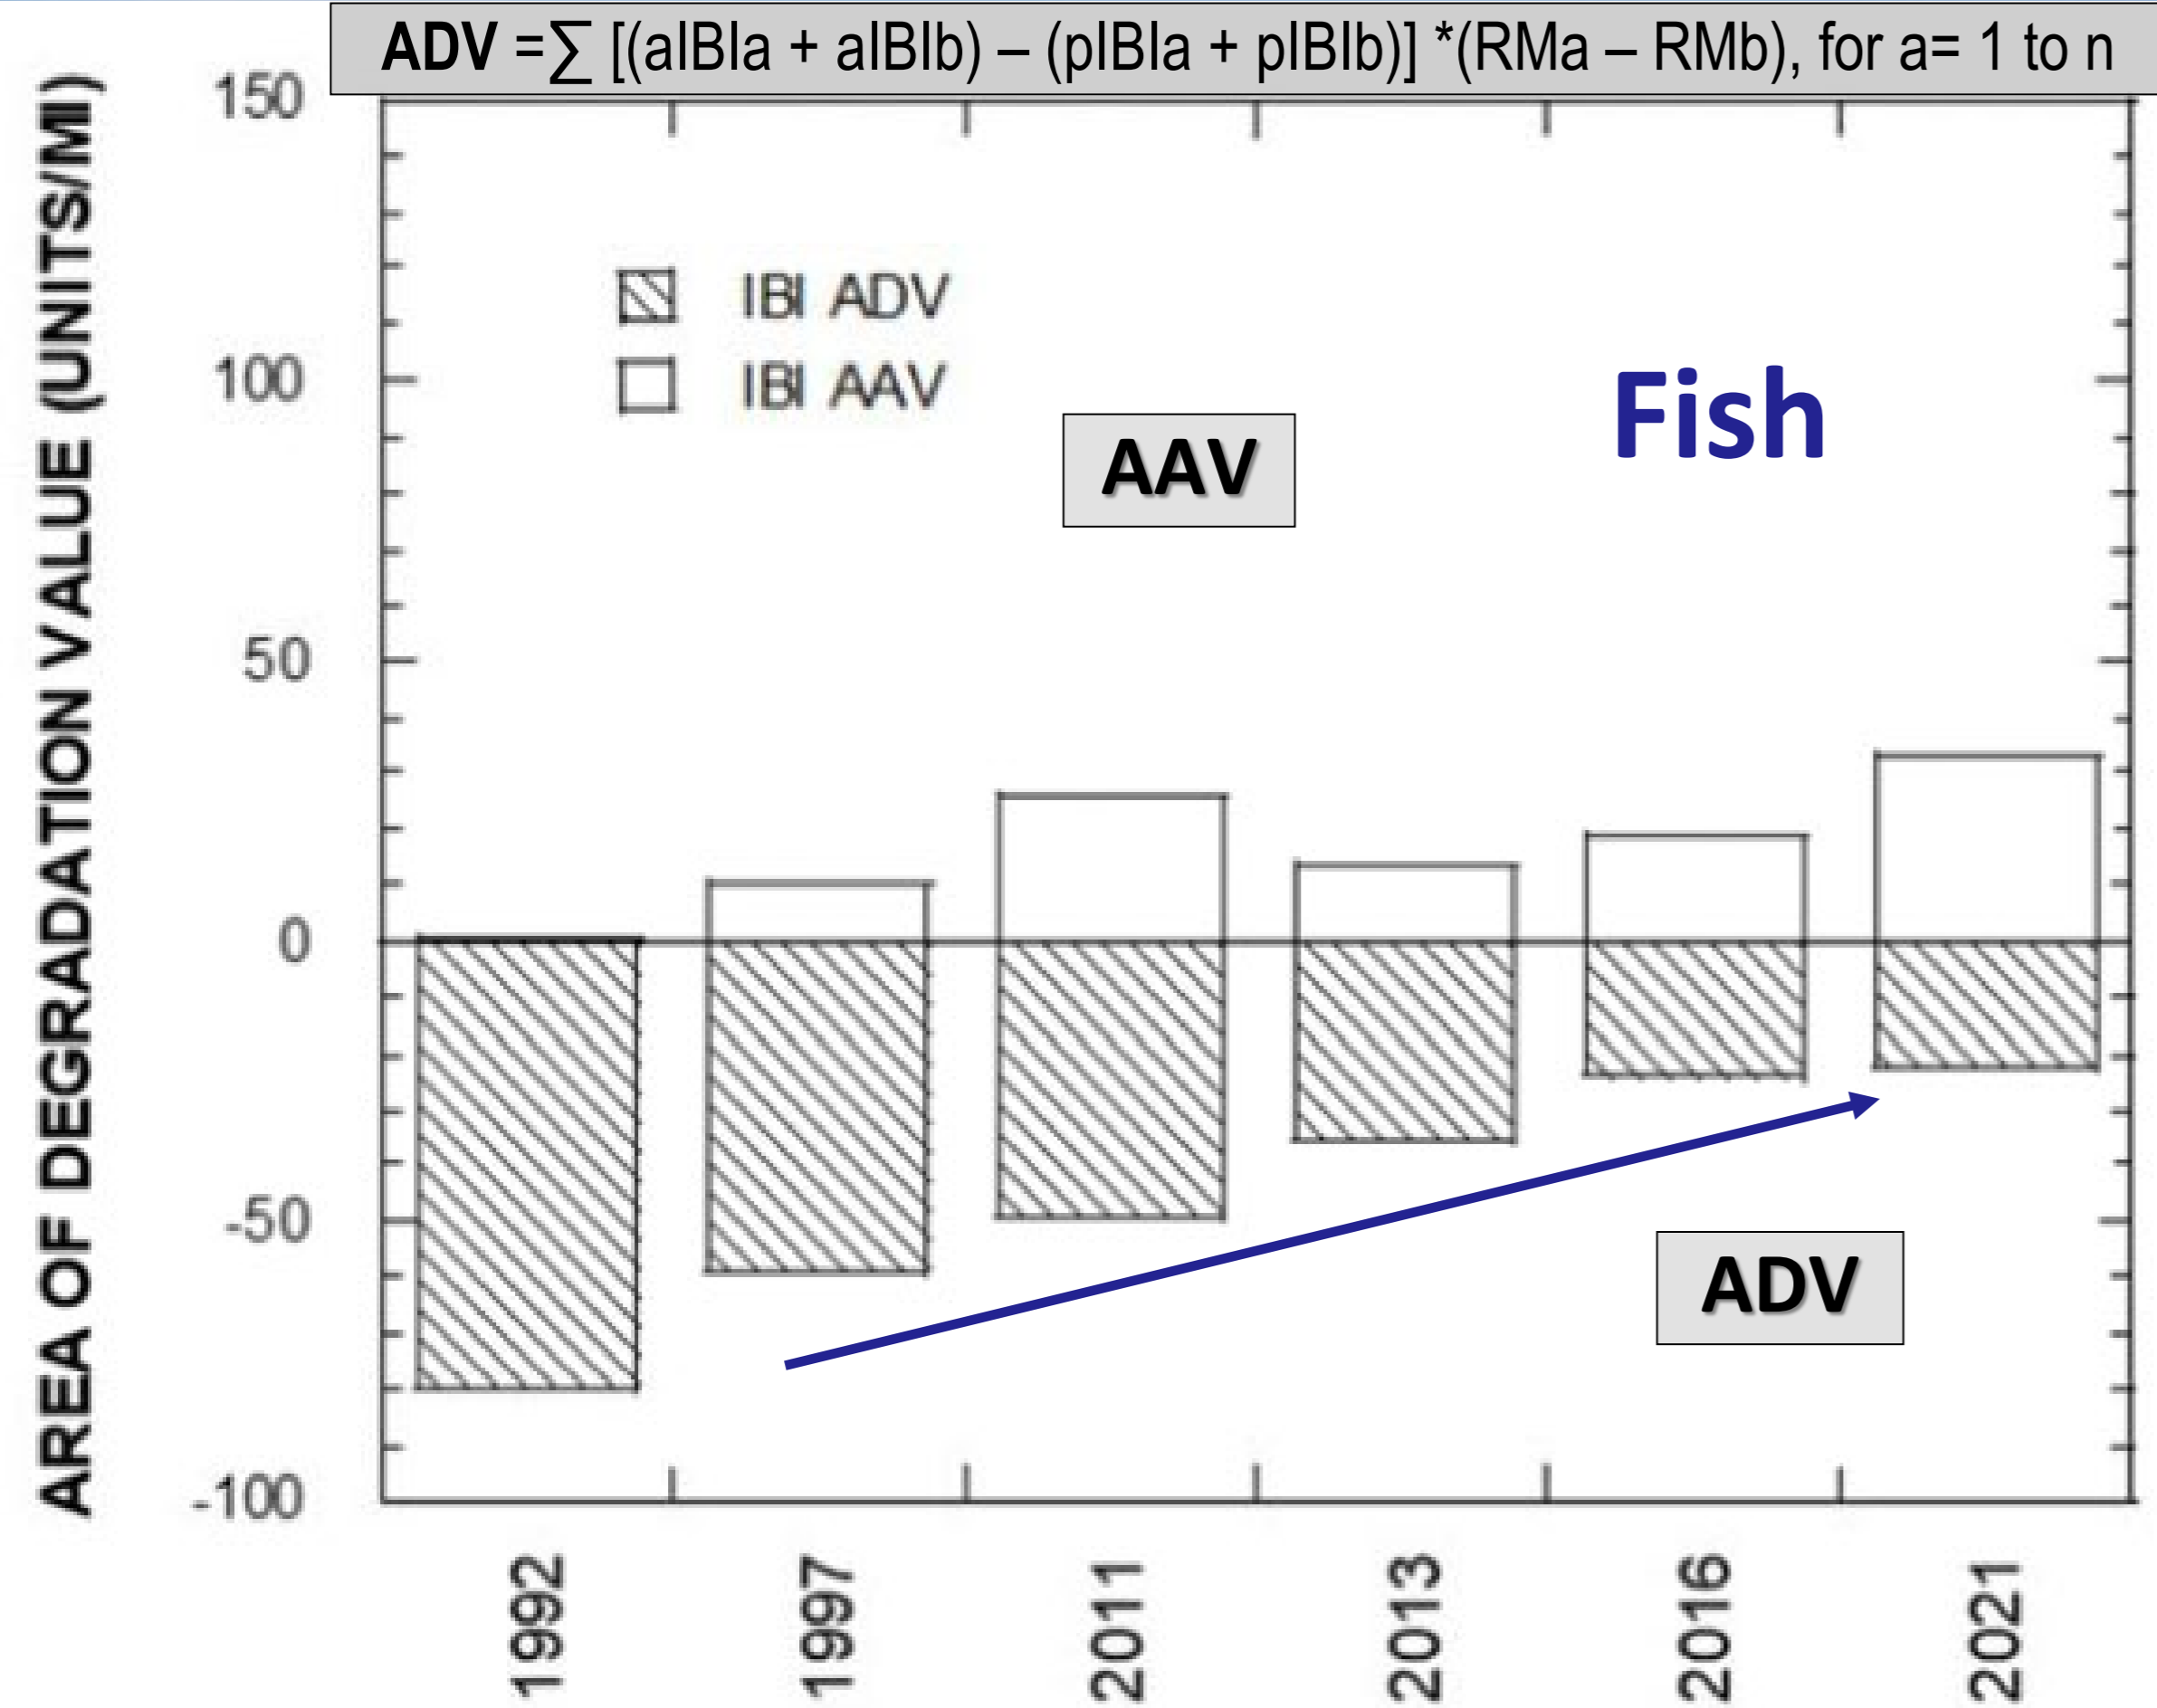
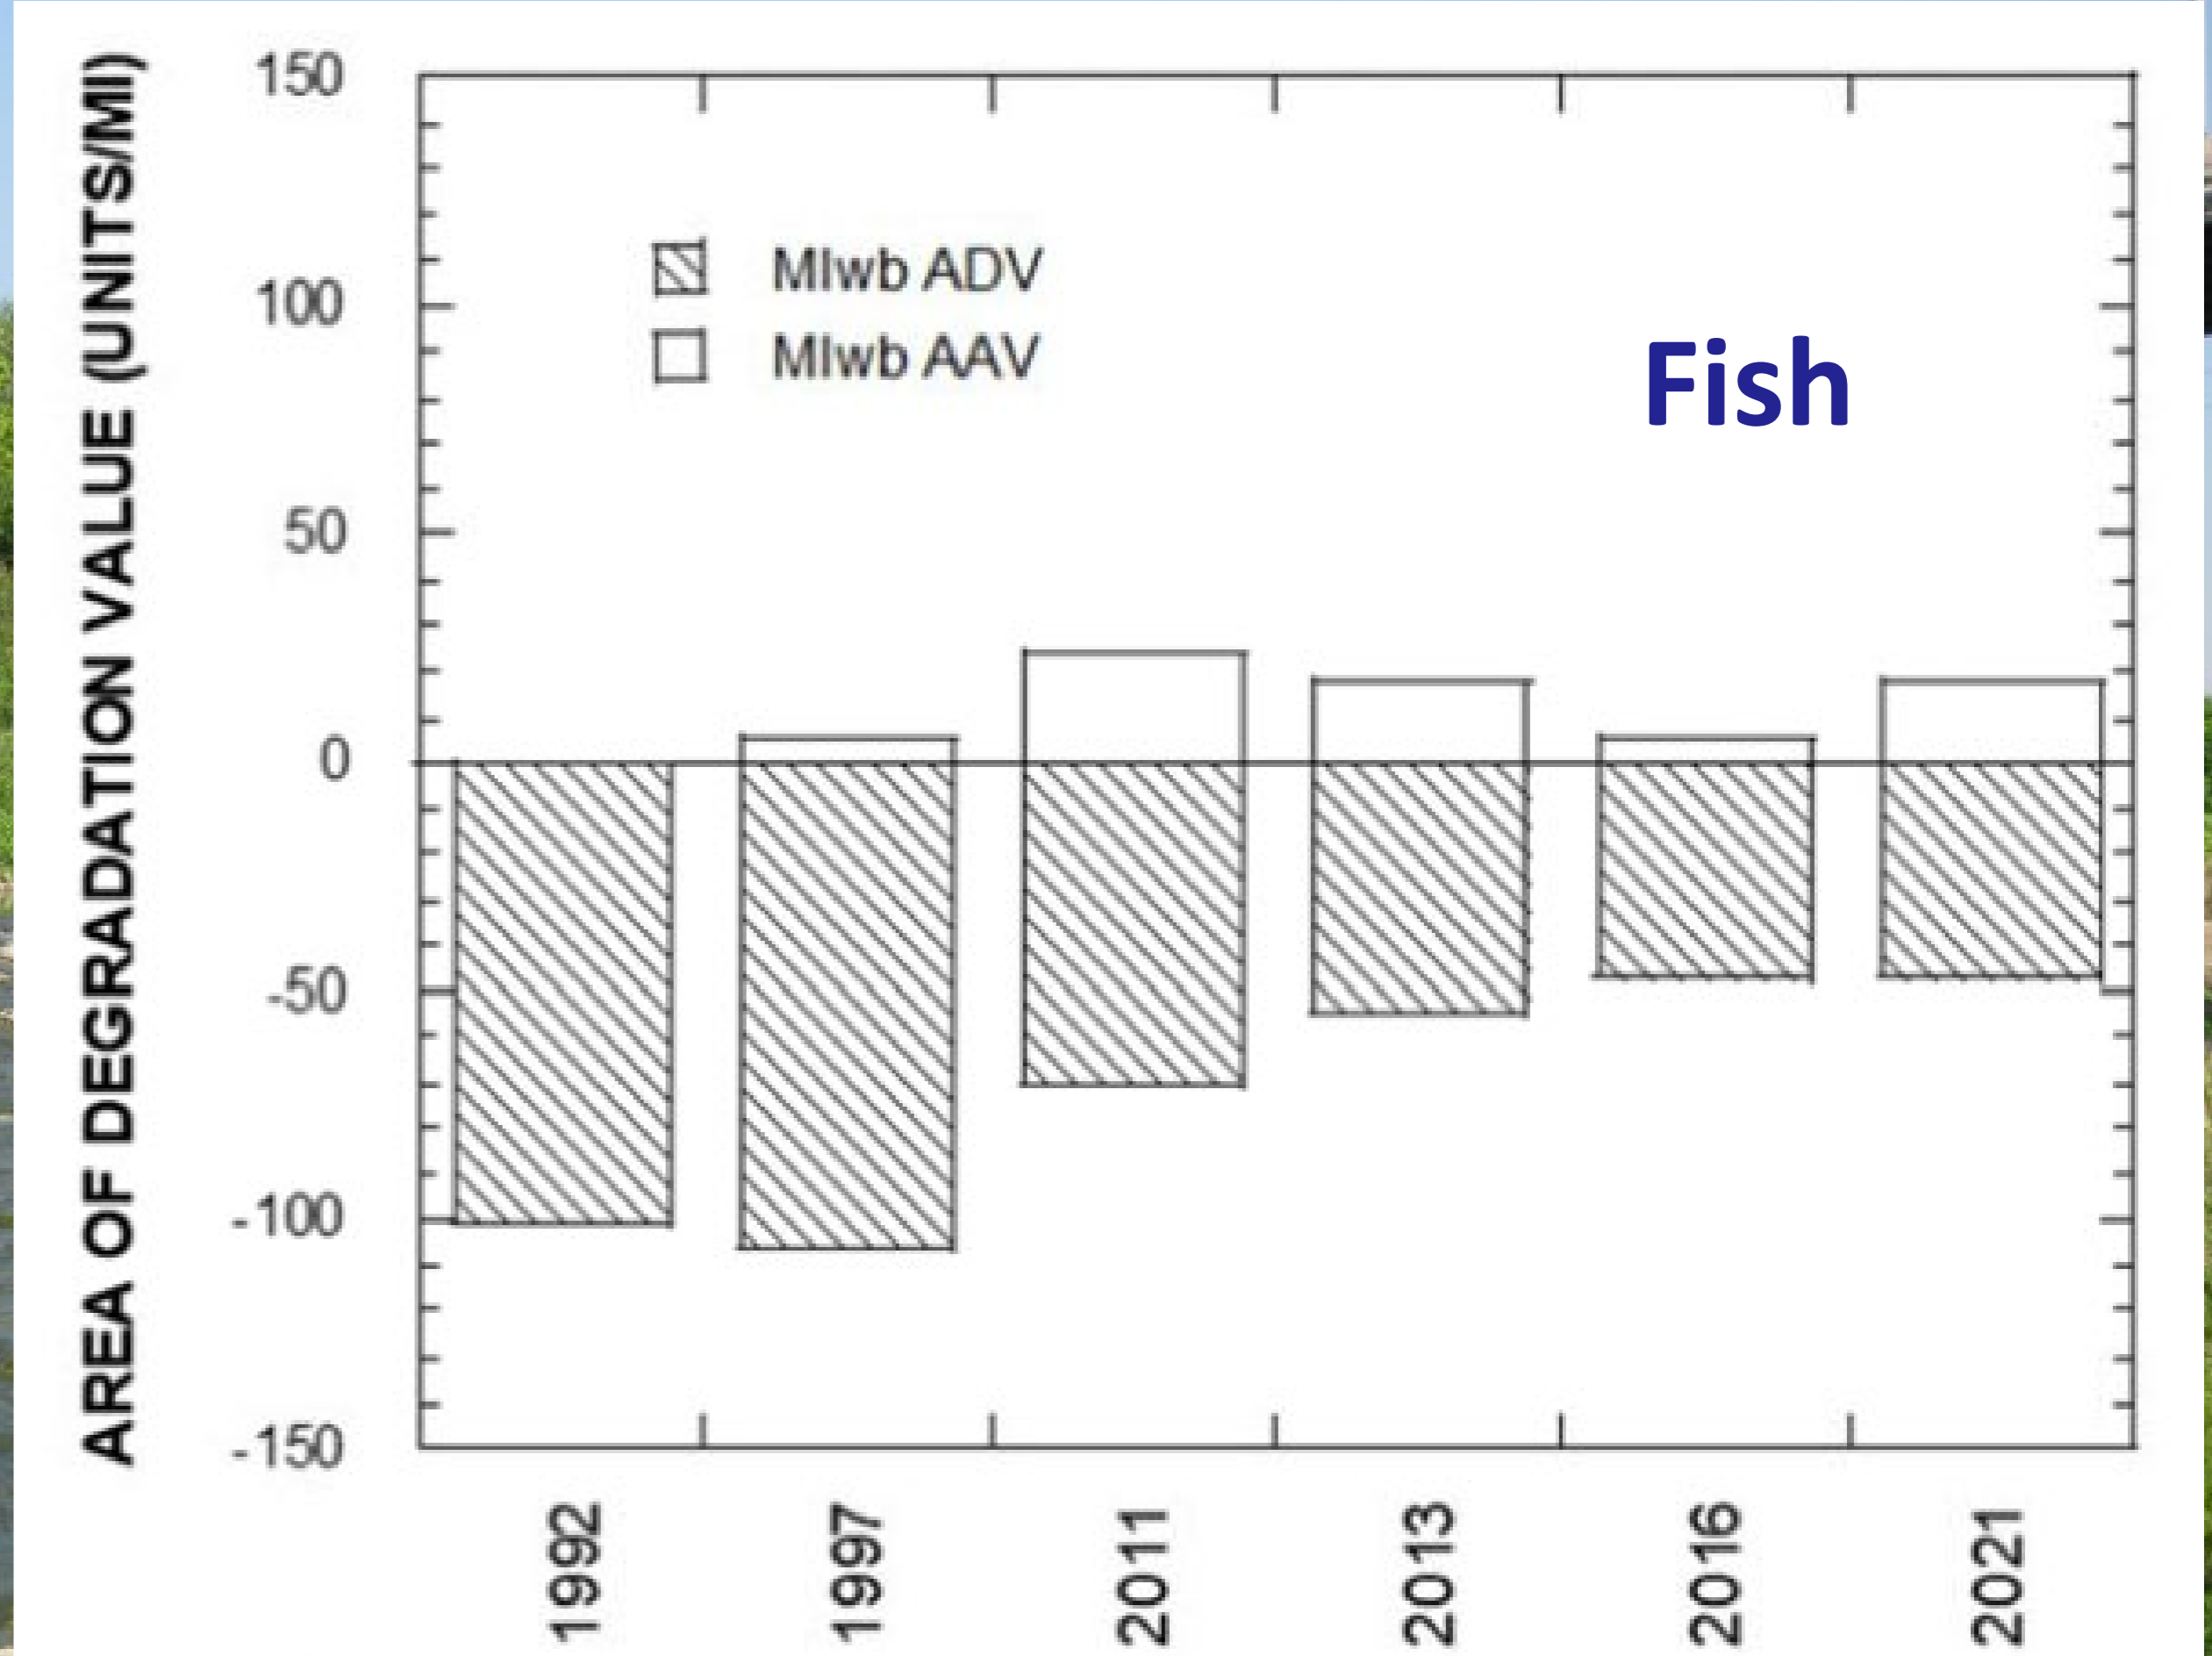
Figure 2. (Page 11) Area of Degradation (ADV) and Area of Attainment (AAV) values

**Index of Biotic Integrity (IBI)** scores the ability to support and maintain a balanced, adaptive community of fish species

**Modified Index of Well-Being (MIwb)** score reflects the overall productivity and diversity of the fish assemblage

**AAV = Area of Attainment Value;  
Meets WQS and by how much**

**ADV = Area of Degradation Value;  
Fails WQS and by how much**

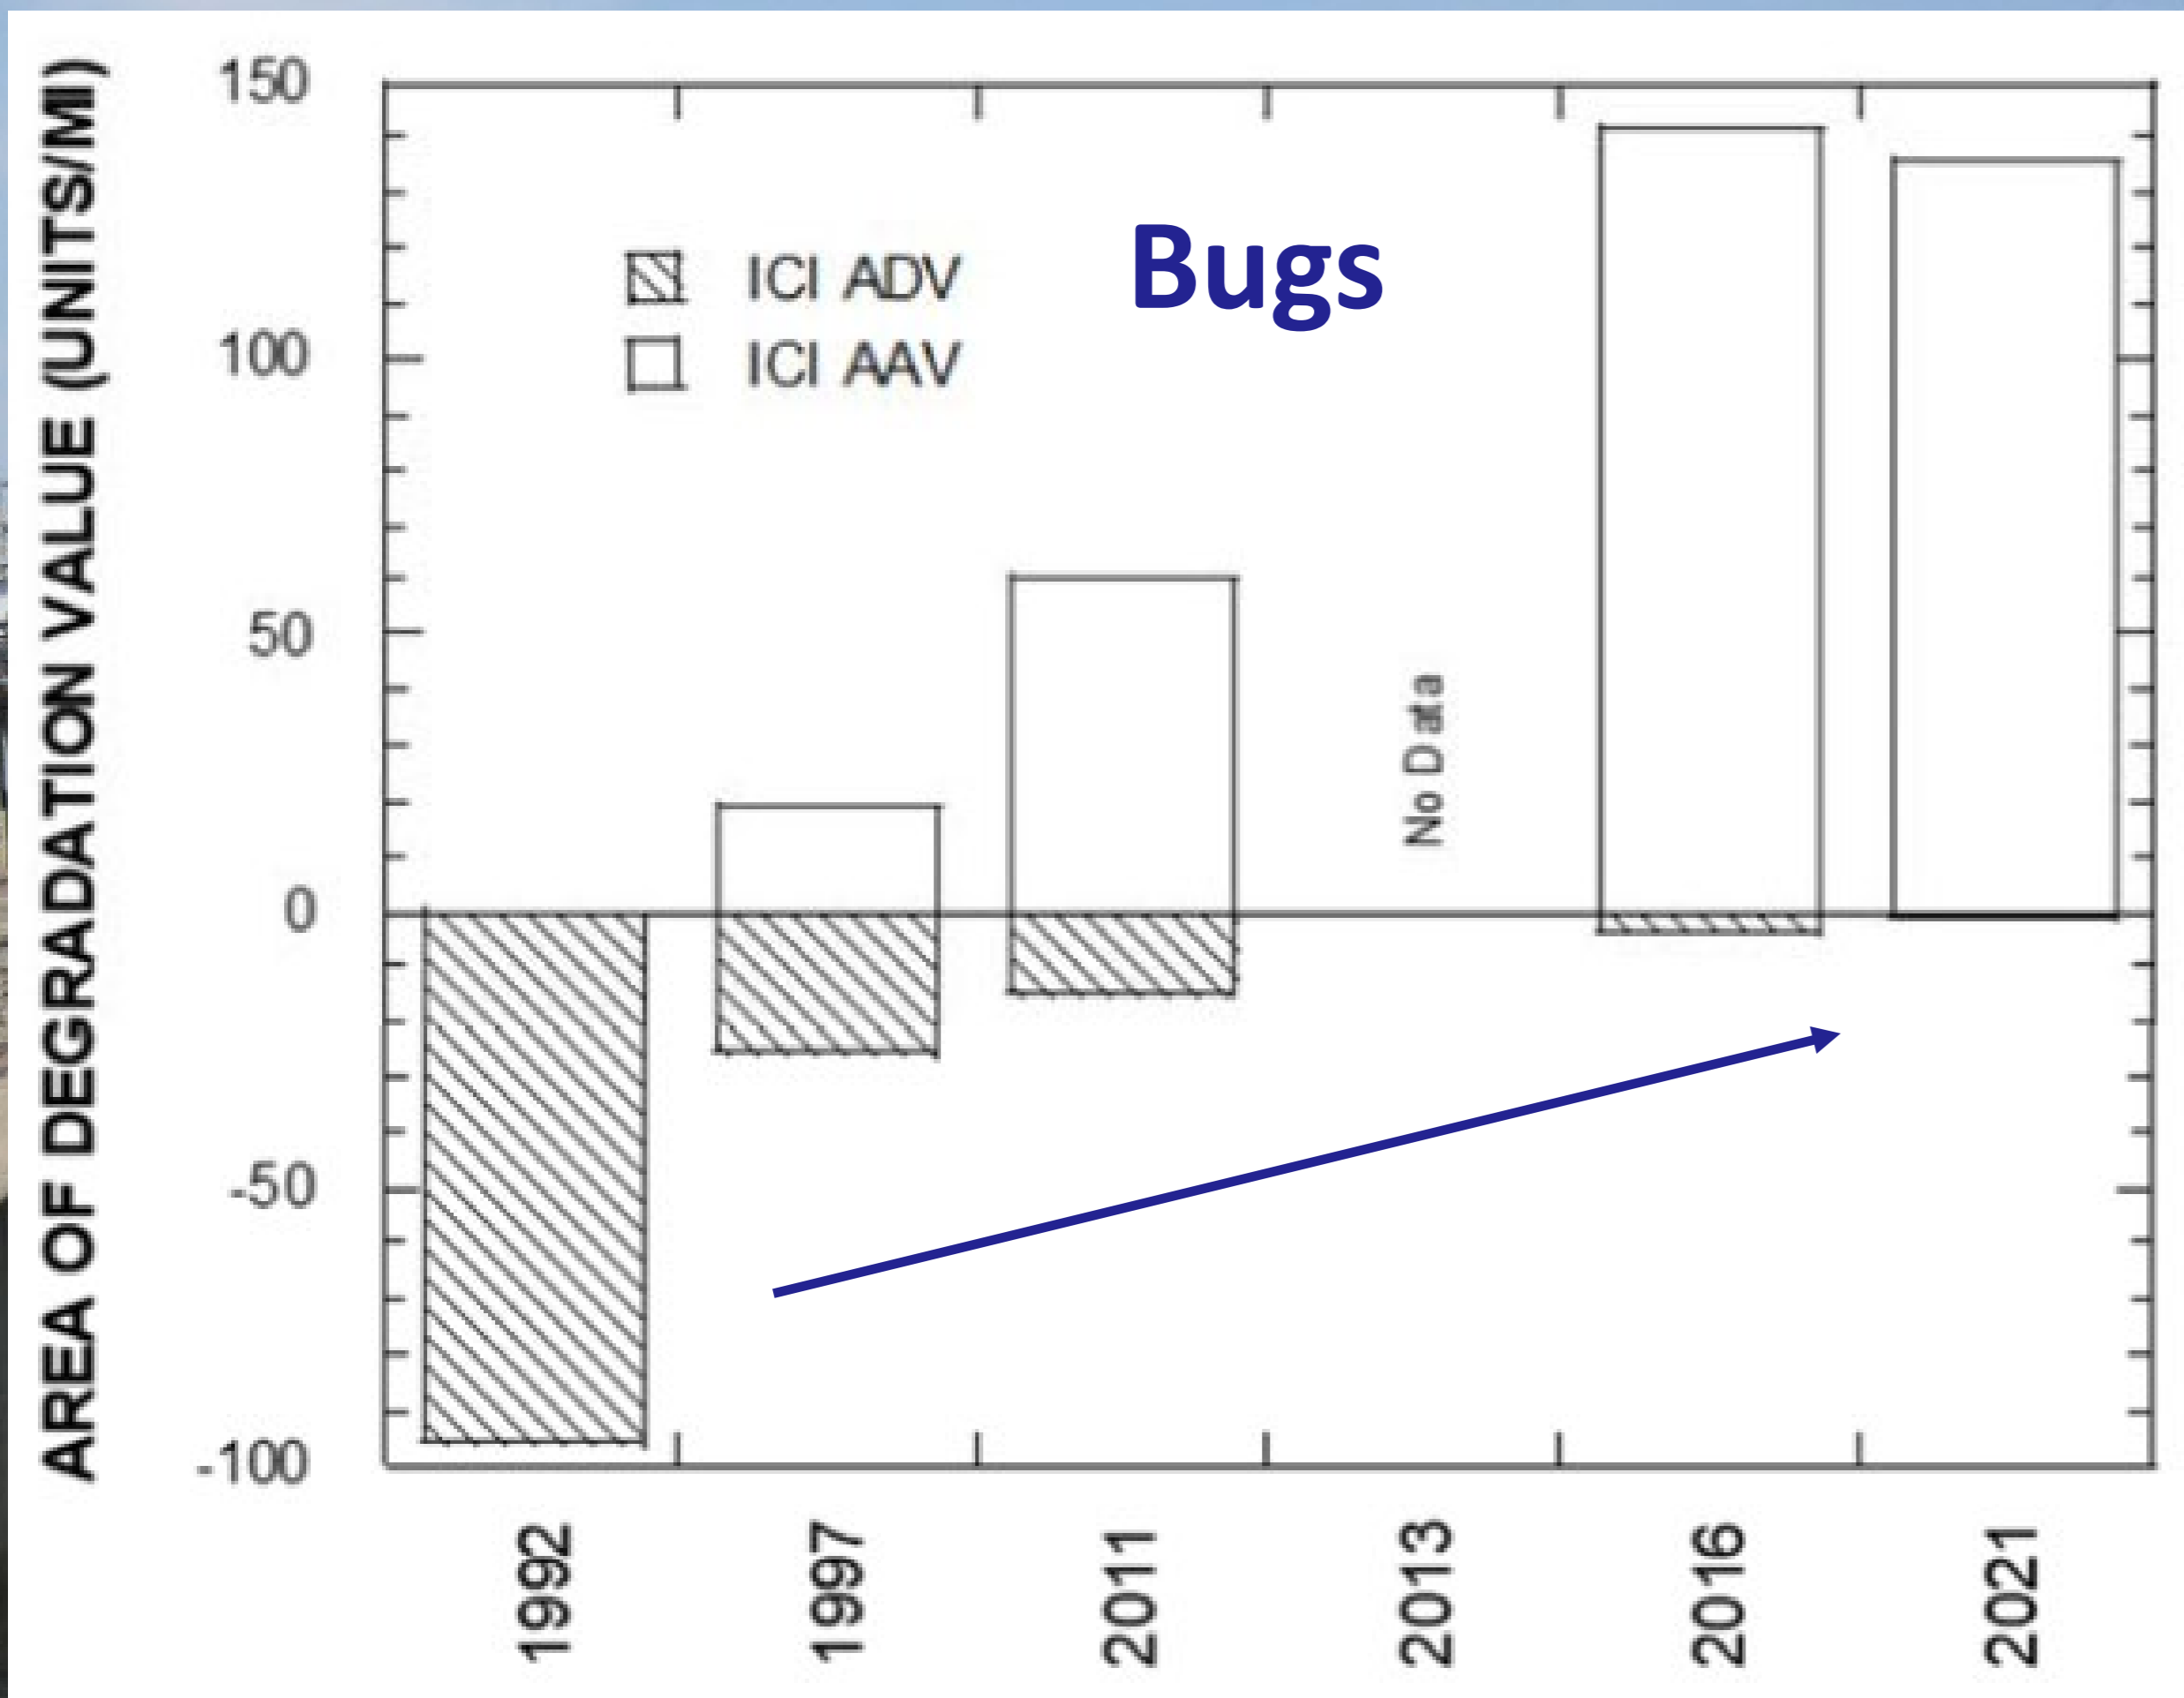
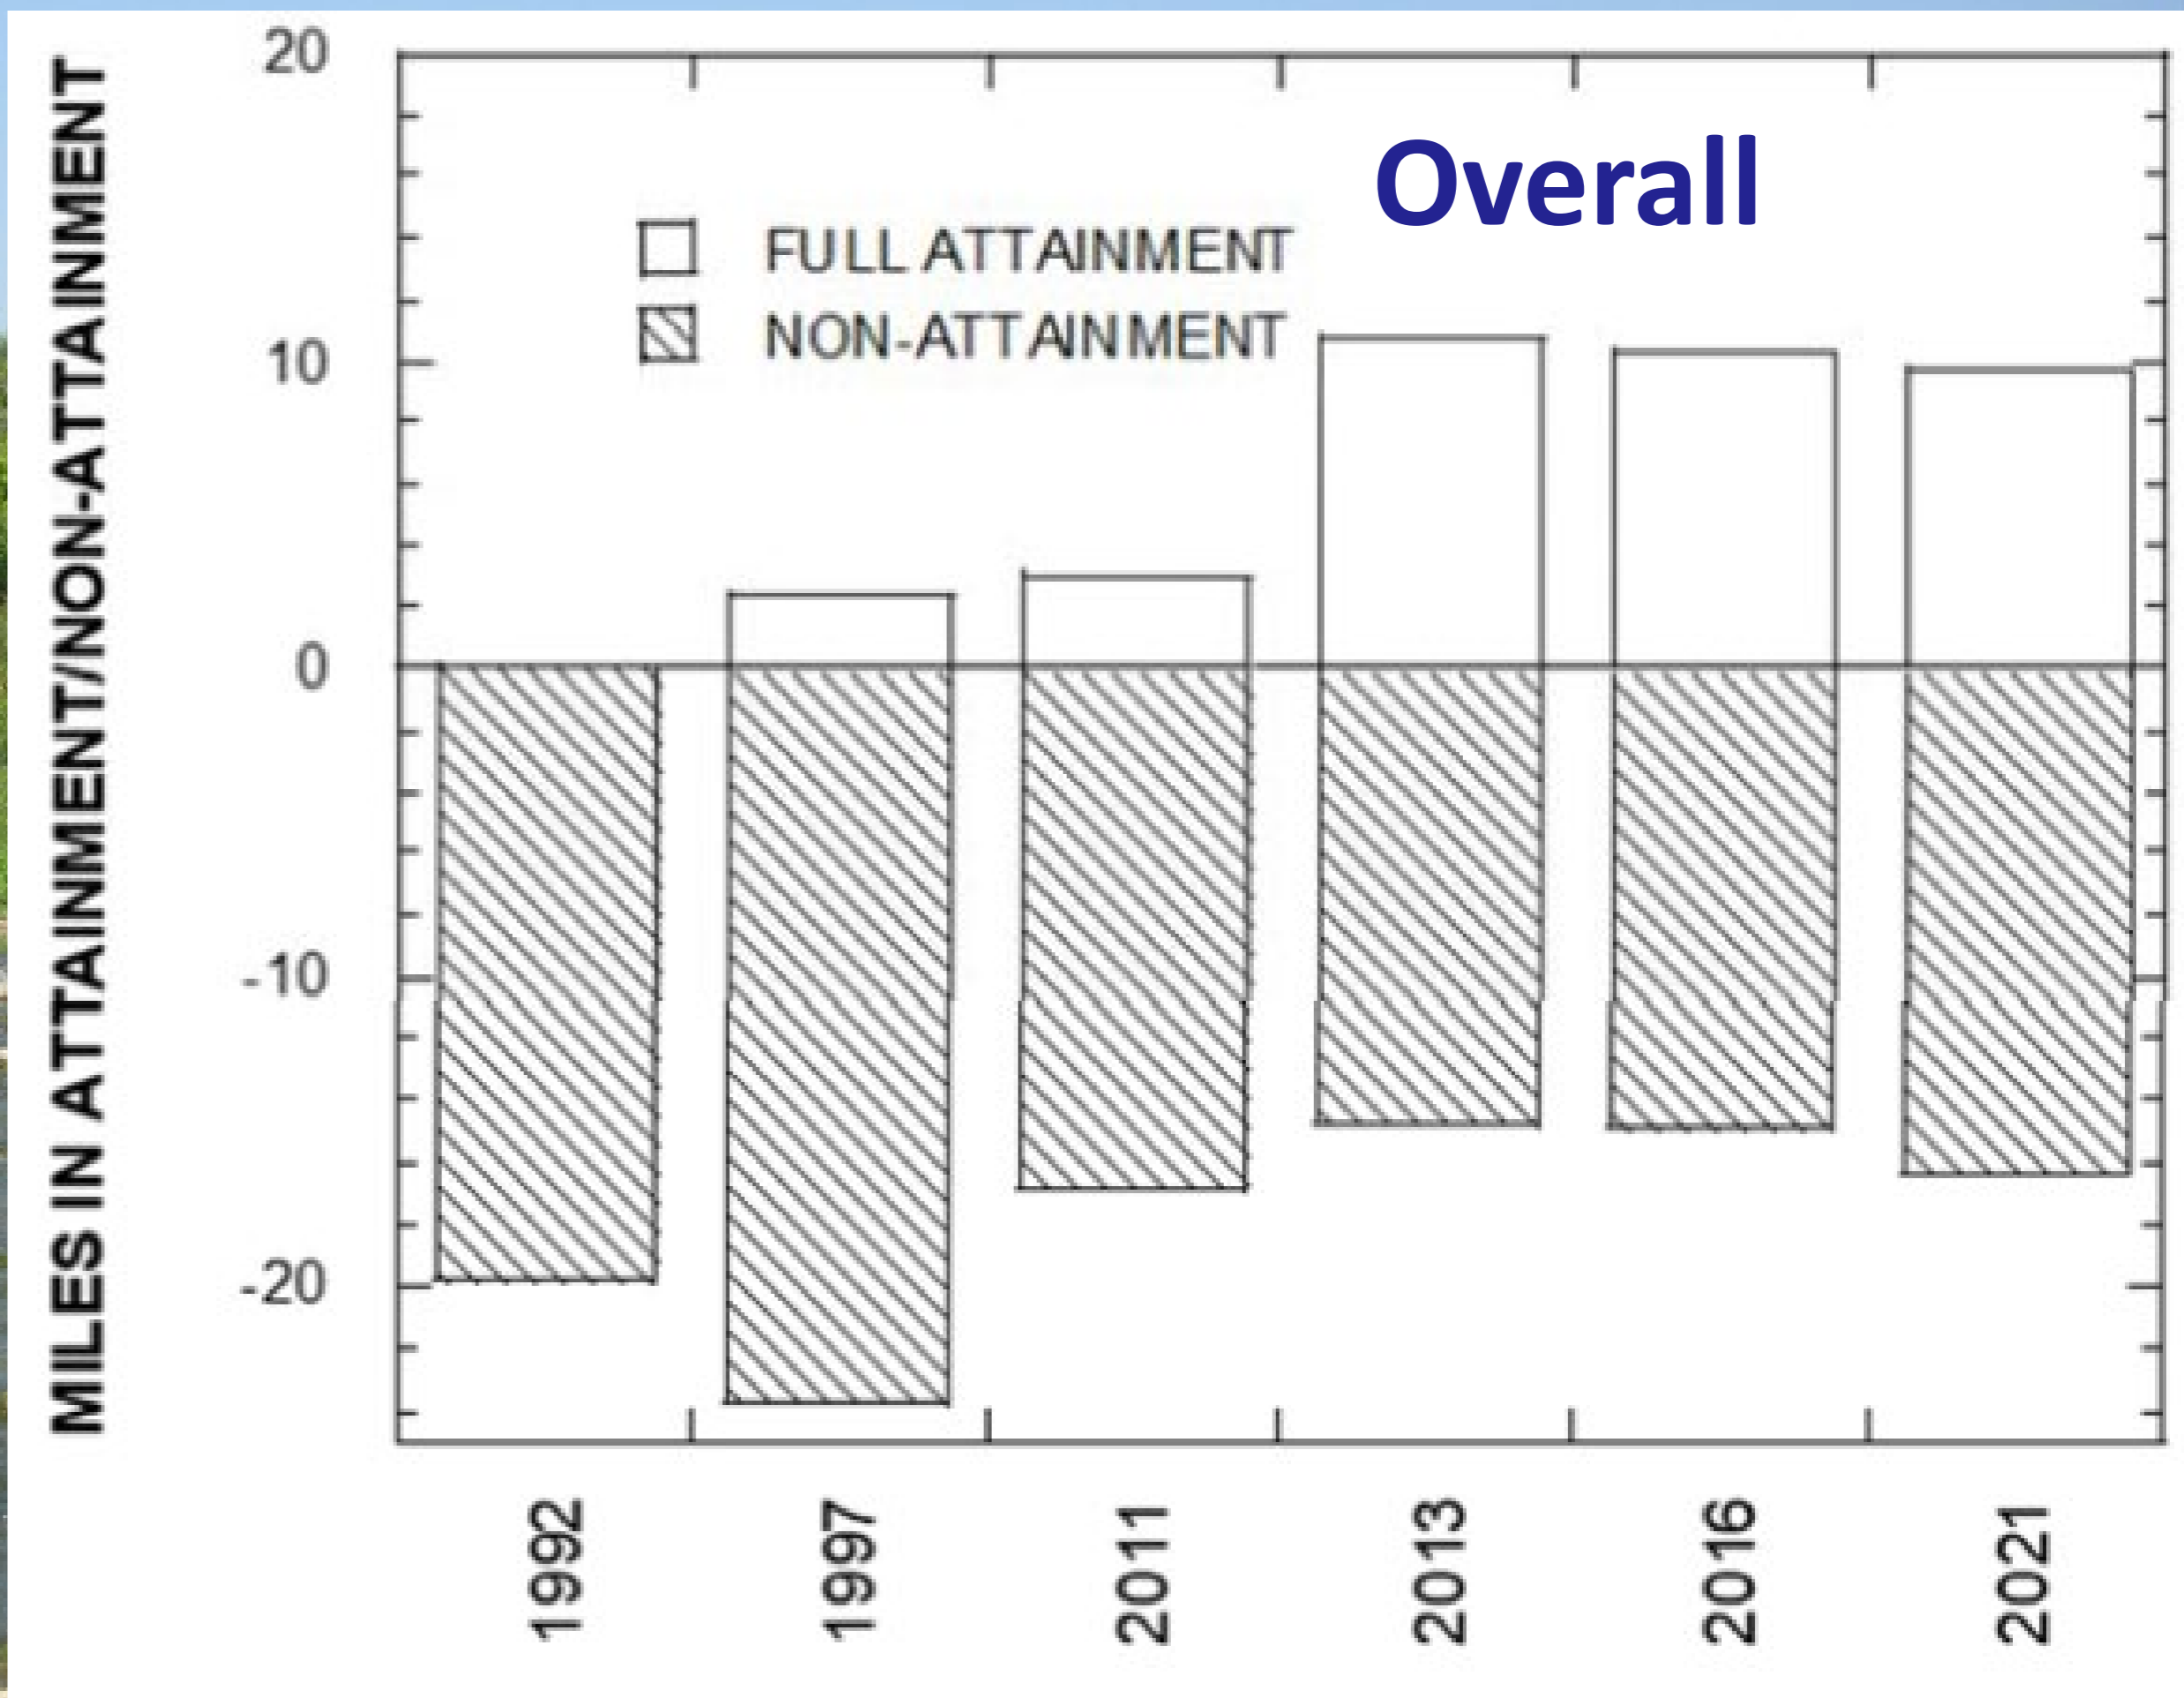
Figure 2. (Page 11) Area of Degradation (ADV) and Area of Attainment (AAV) values

**Invertebrate Community Index (ICI) scores** measures the health of the macroinvertebrate community

**Stream miles in full attainment over miles in partial or non-attainment**

**AAV = Area of Attainment Value;  
Meets WQS and by how much**

**ADV = Area of Degradation Value;  
Fails WQS and by how much**
