# 2022 Water Quality Forum

Mill Creek Basin

MSD Administration Building  
December 14, 2022

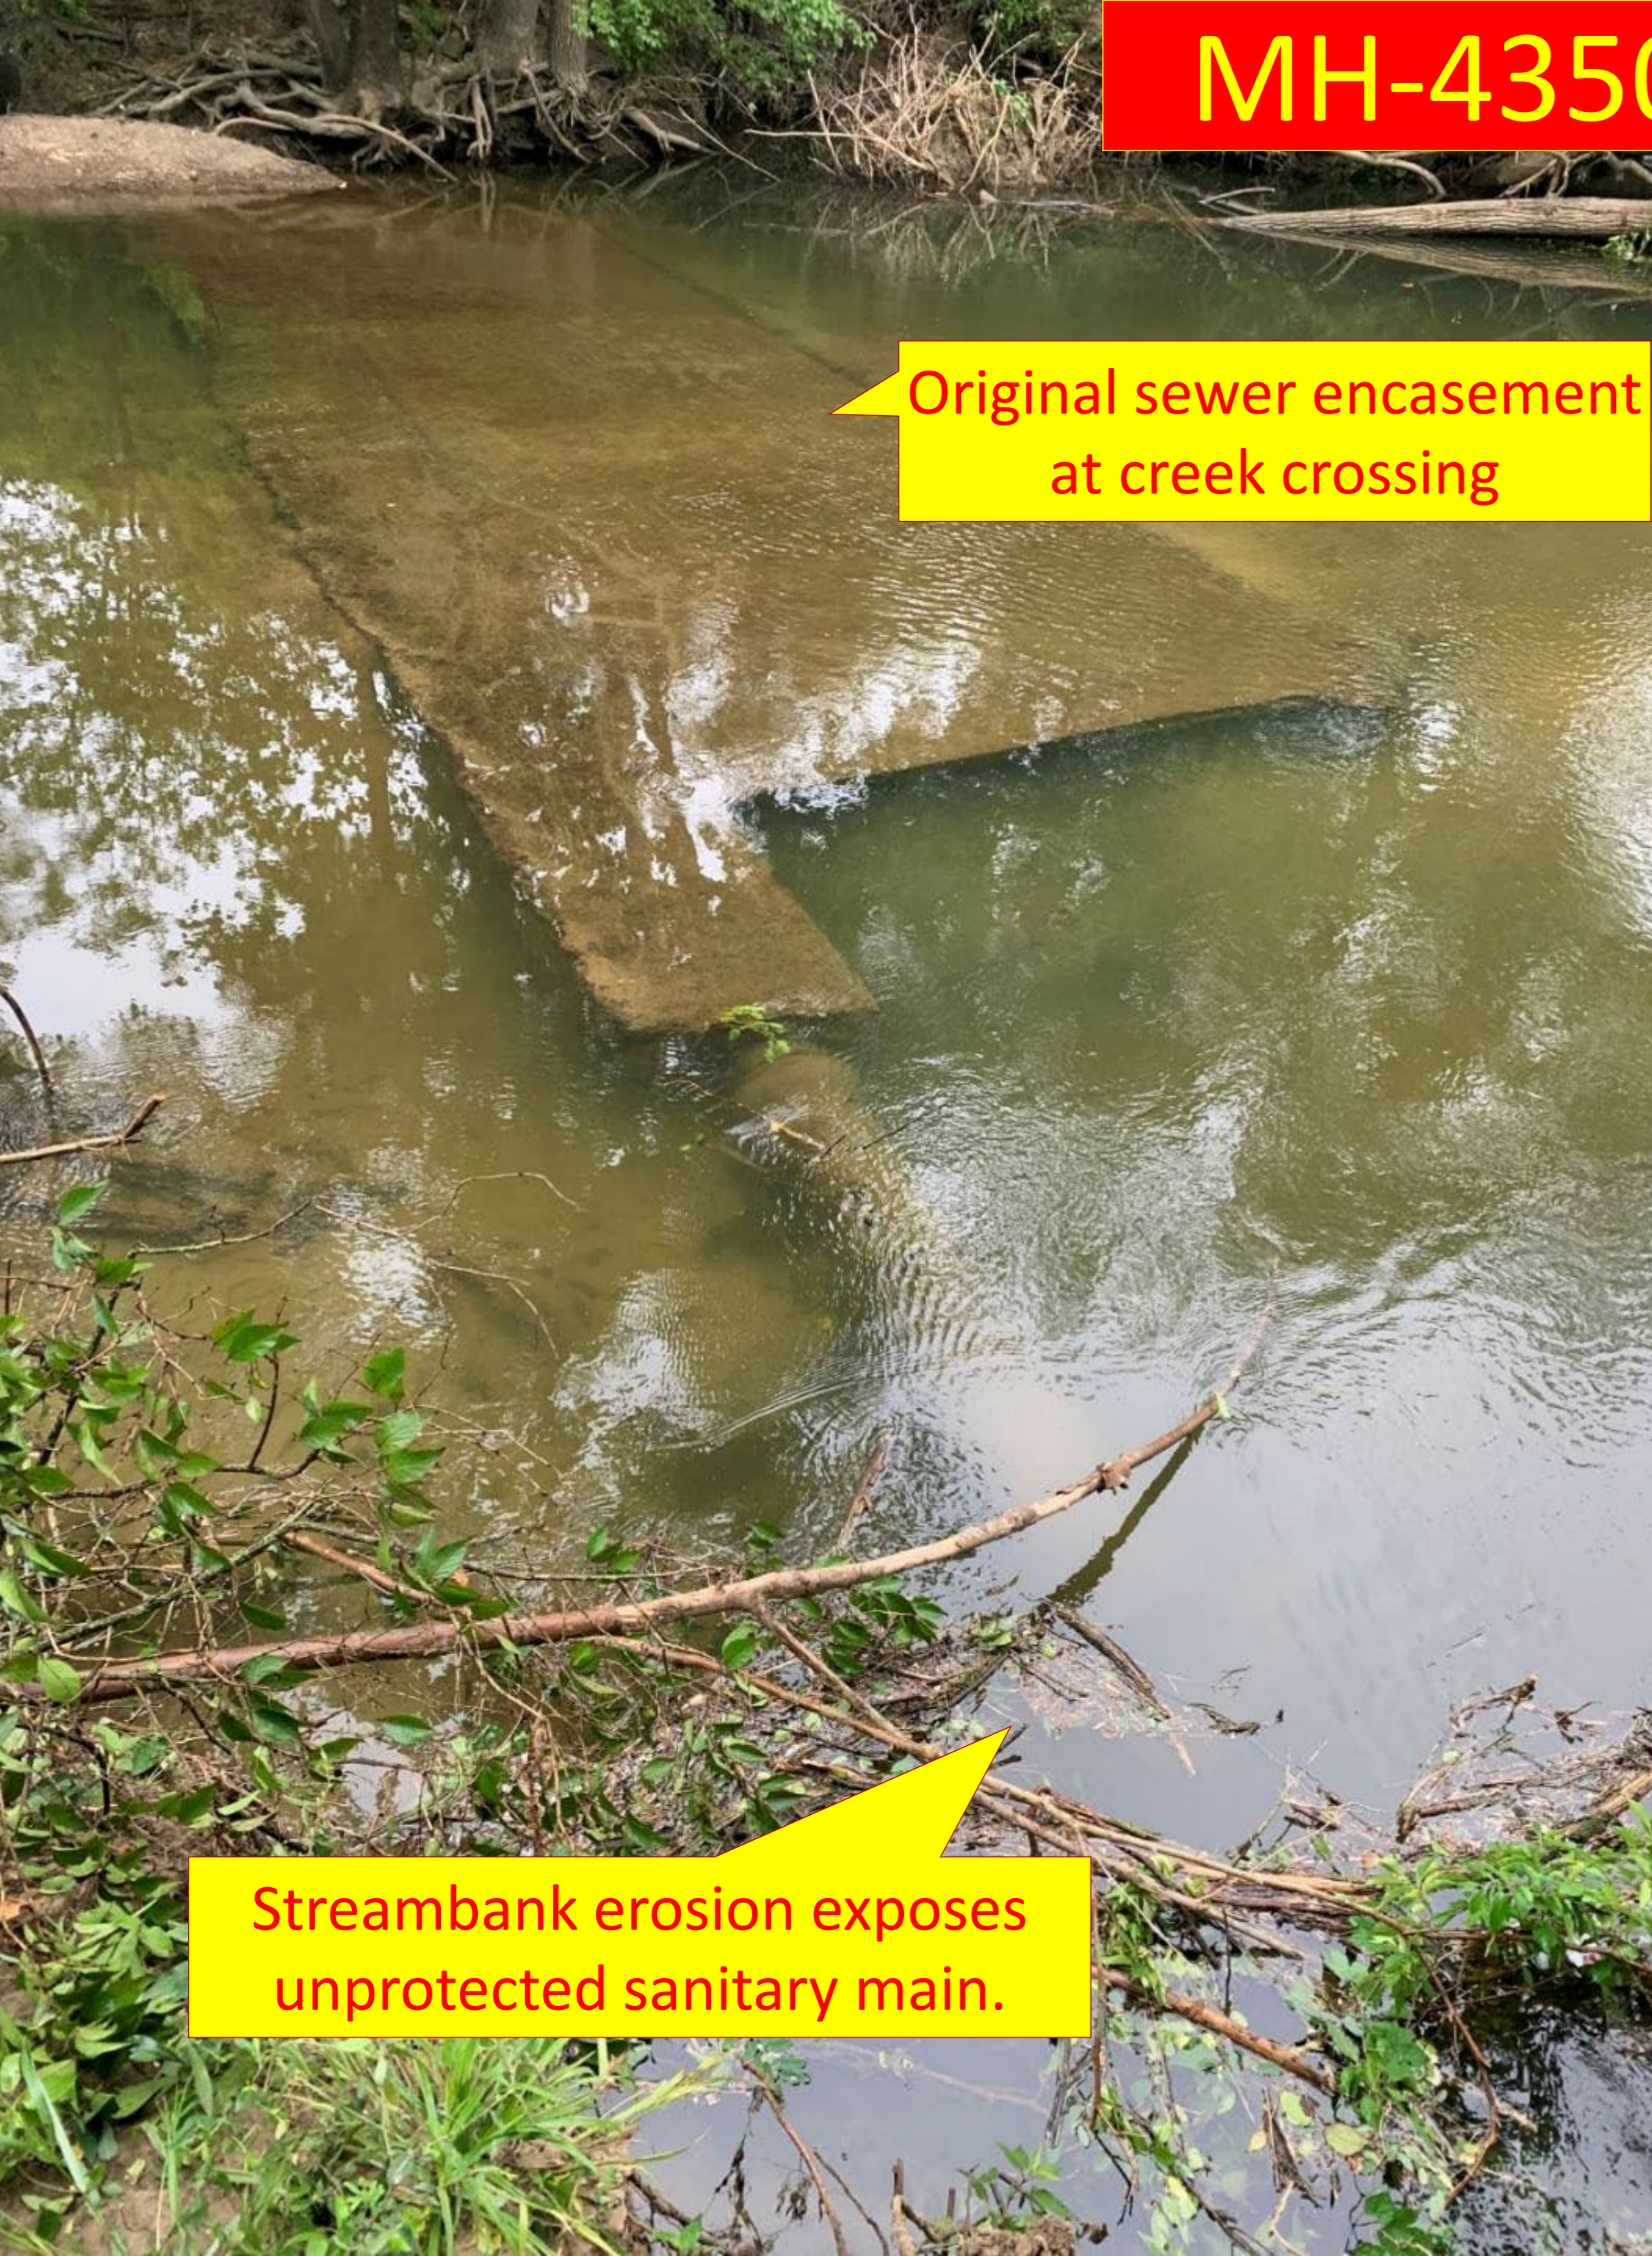
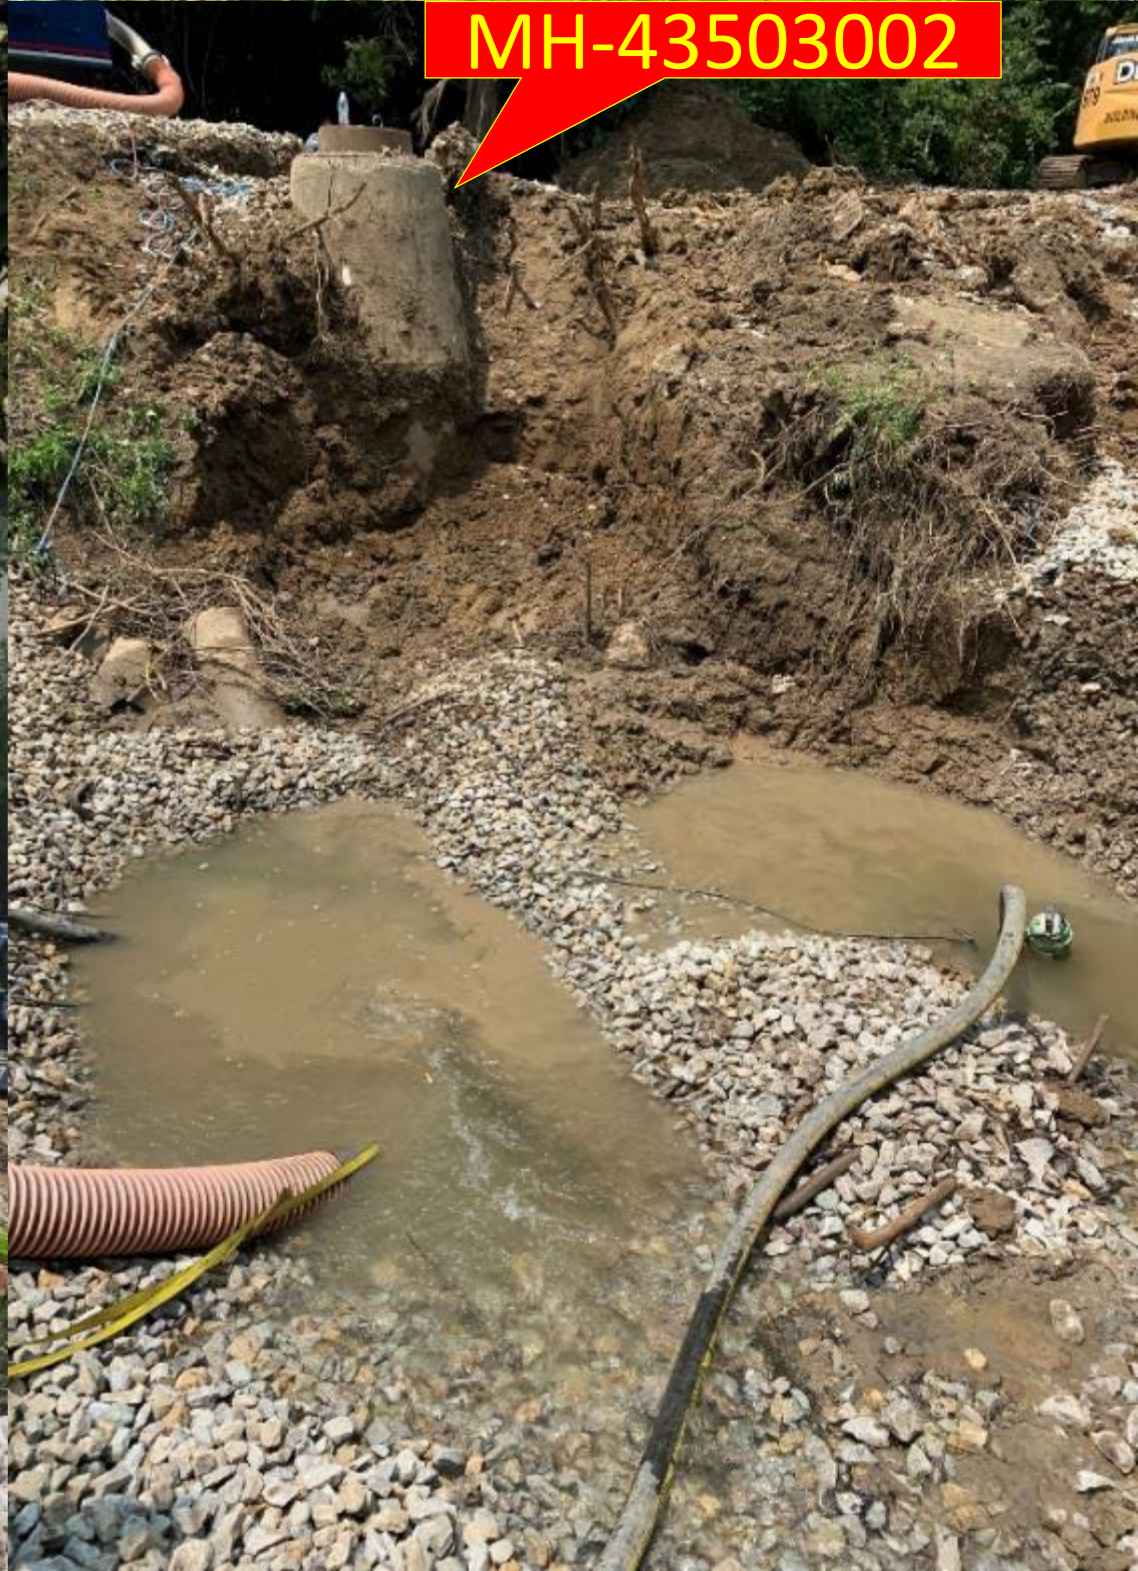
# MH-43503002 mainline repair

Original sewer encasement at creek crossing

Streambank erosion exposes unprotected sanitary main.

07/22/2021 [CLH] MSD maintenance bypassed the US line to remove flow from repair. The crew removed existing pipe and placed #2 gravel for a bed. The crew installed ductile iron pipe. They reinforced the pipe with lengths of angel iron sections pushed in next to pipe. The crew formed an area around pipe and poured fast set concrete. Two of the bypass pumps were left running for the weekend.

06/2/2021 [JAR] Repair is needed on 12" mainline section 43503009-43503002. TV inspection is unable to be completed without bypass pumping line. Sewage appears to be surfacing in the creek near the west bank where the creek has eroded past the original concrete encasement on mainline near MH 43503002.

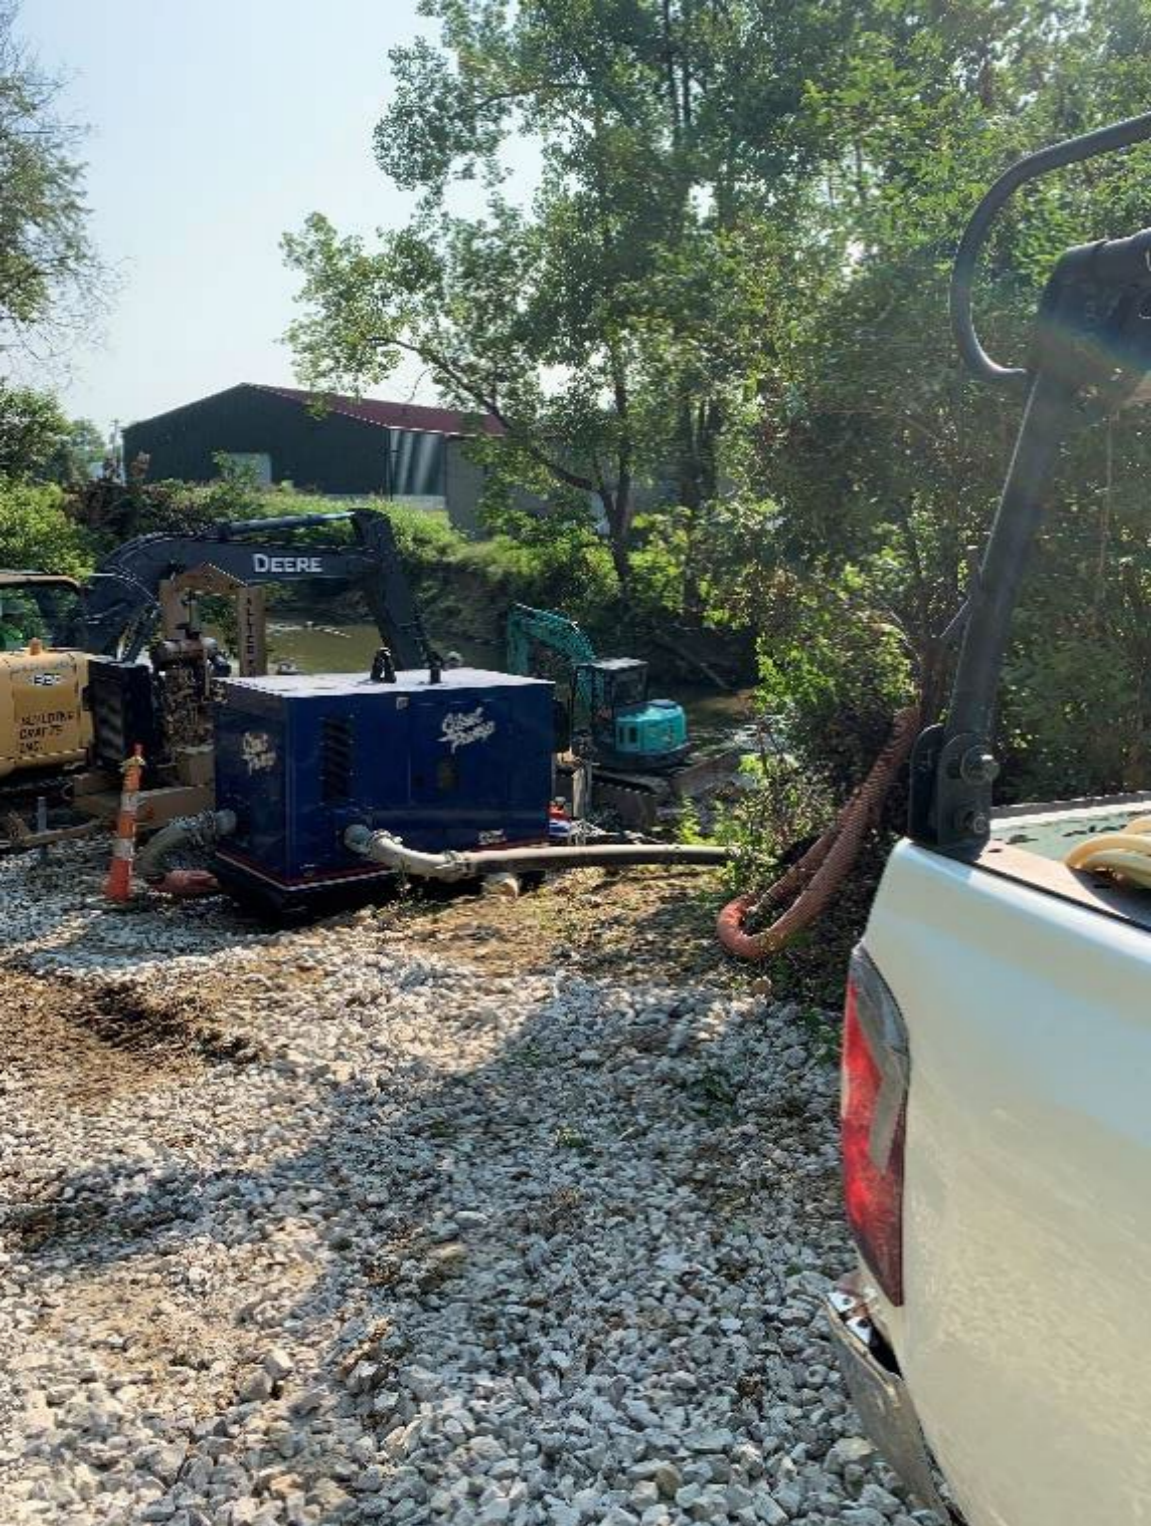
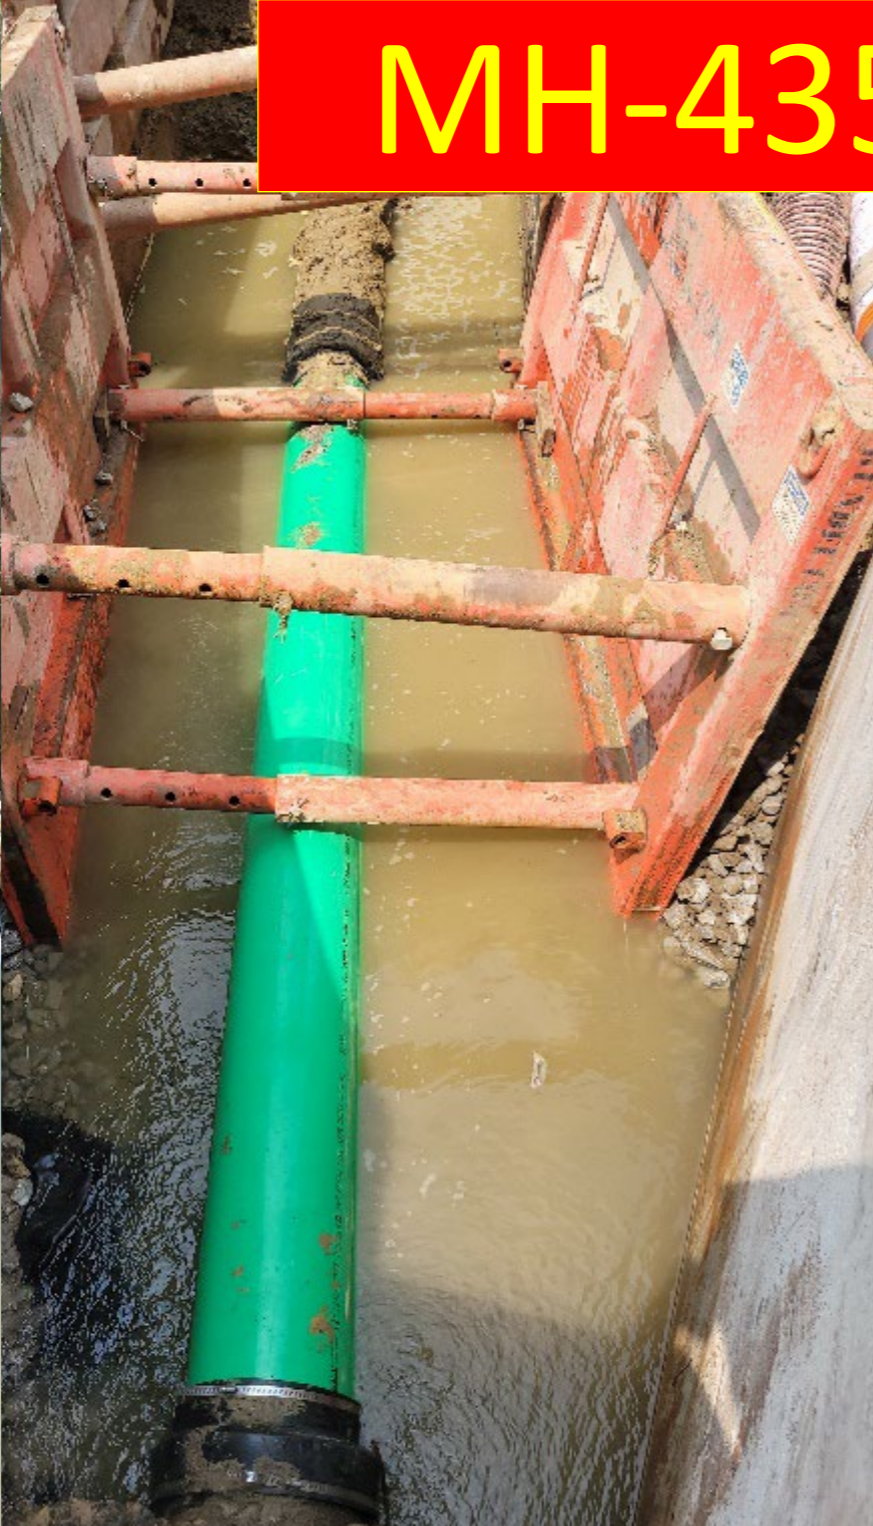
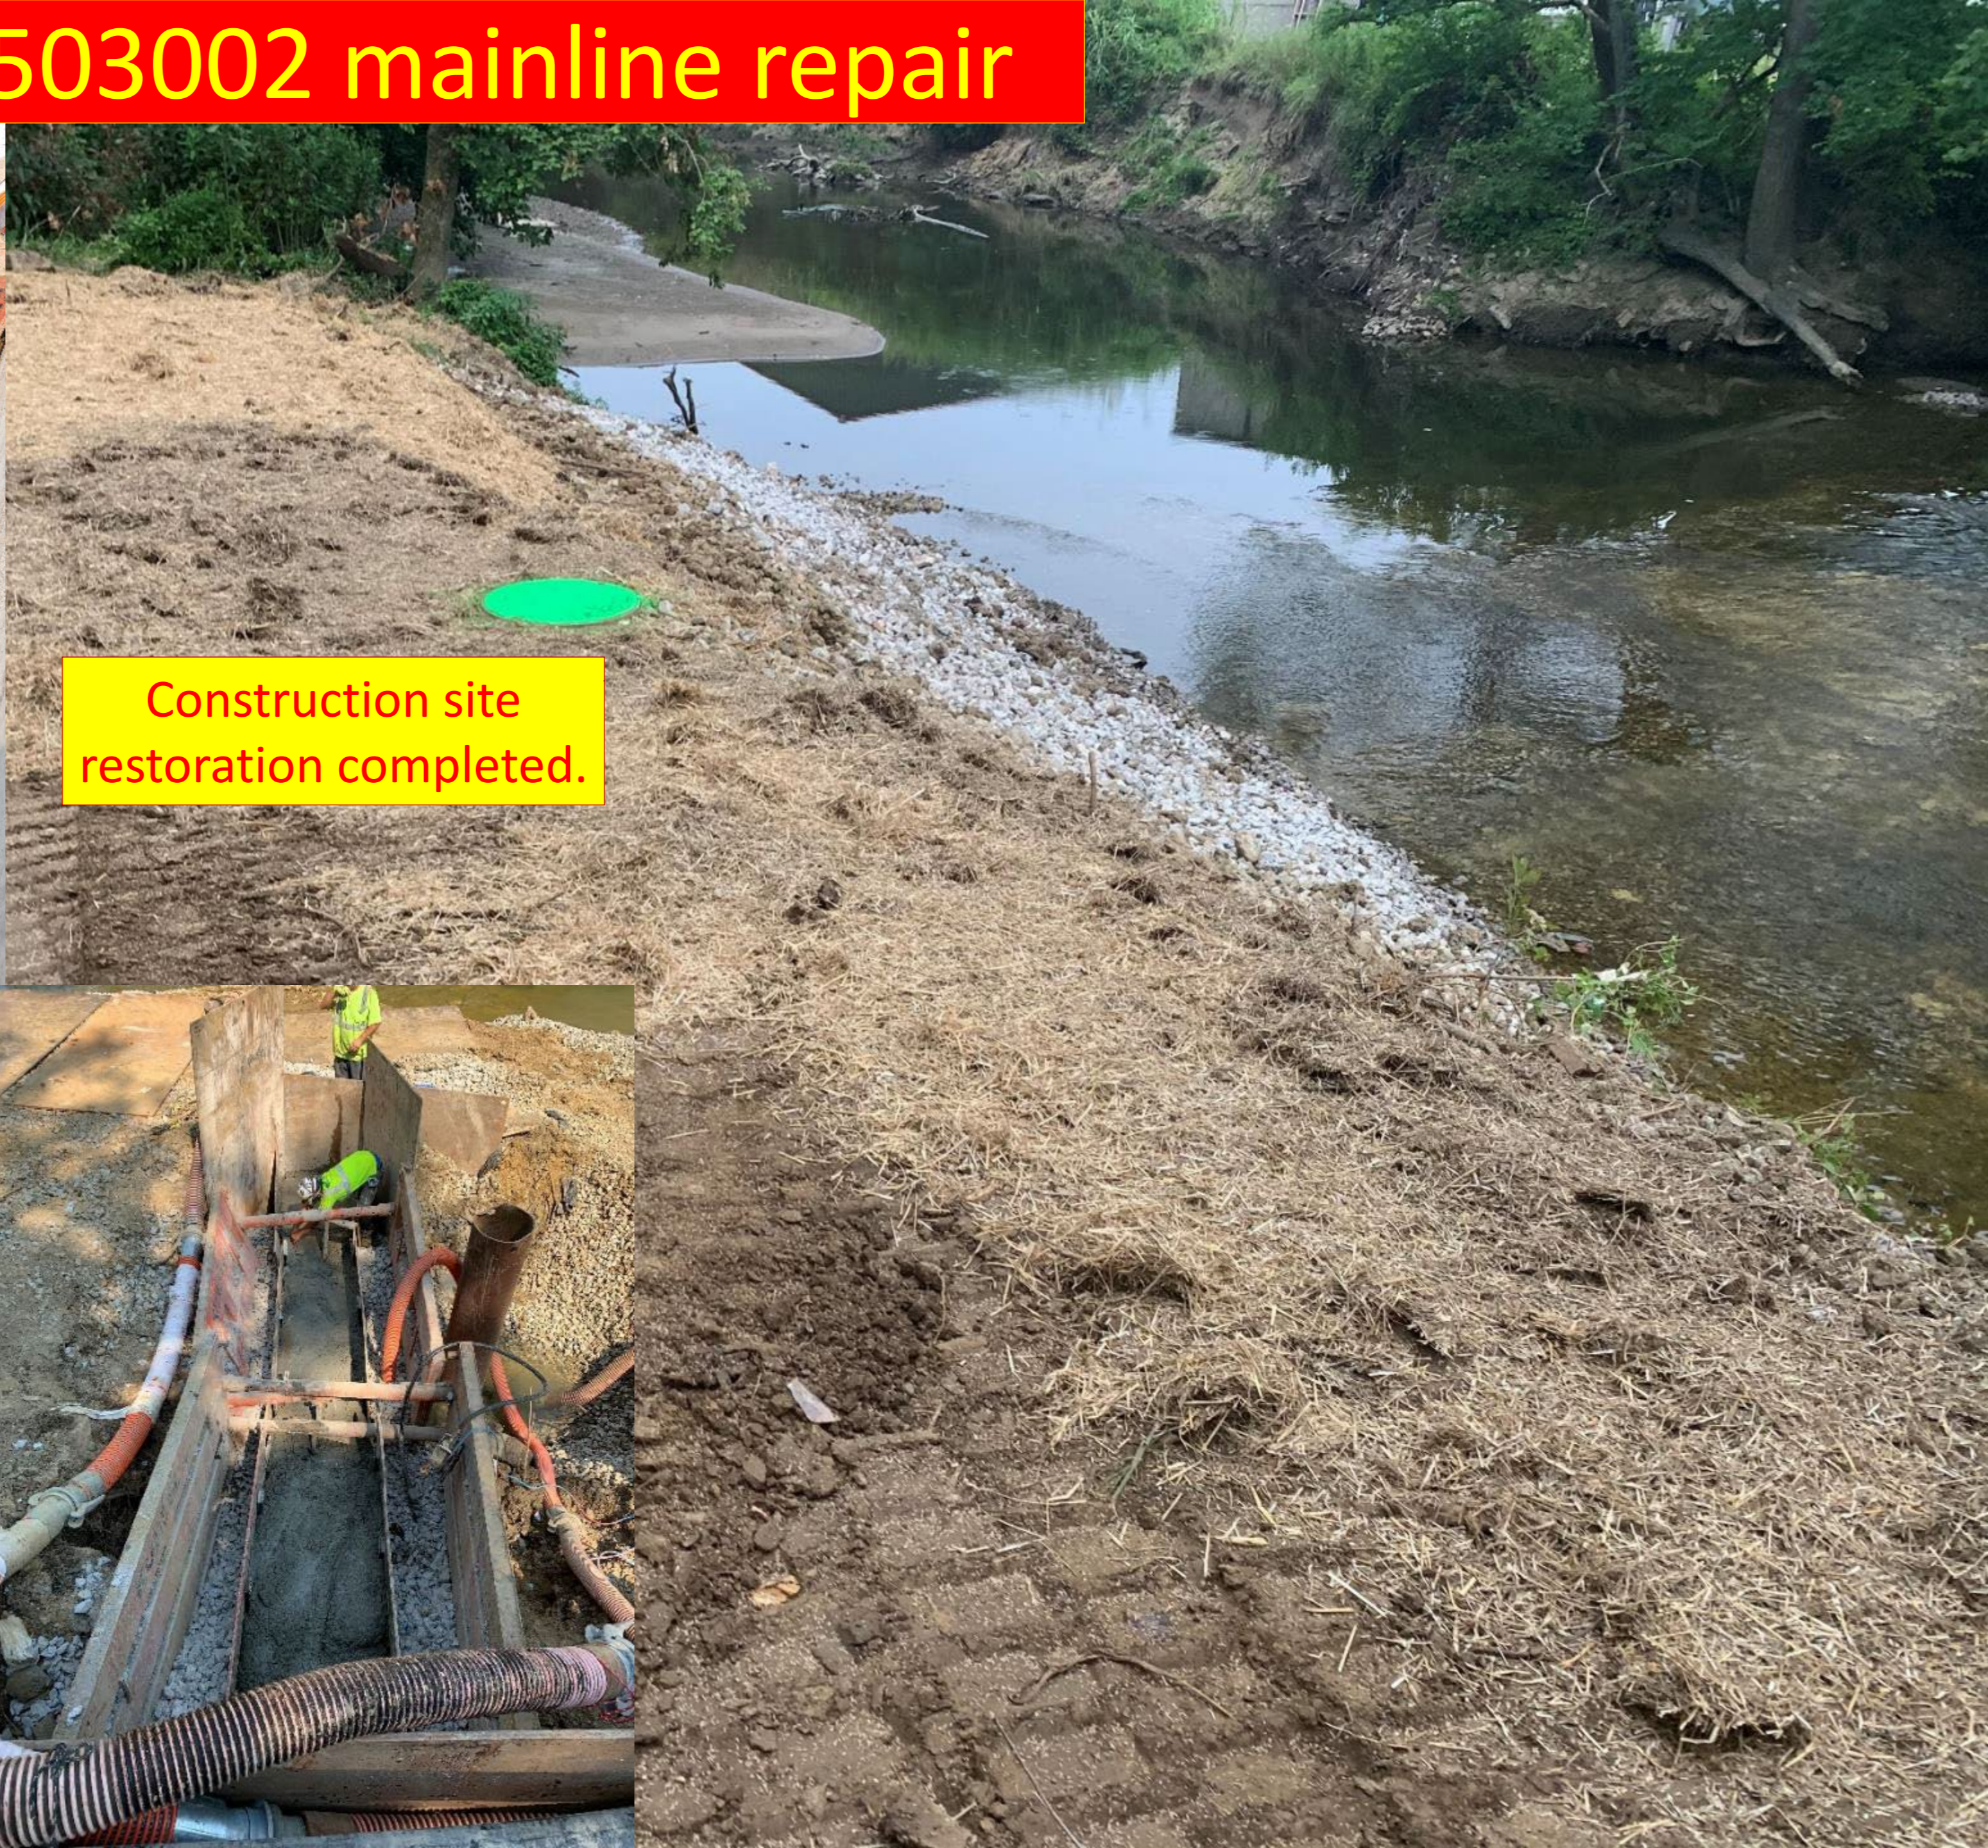
# MH-43503002 mainline repair

Construction site restoration completed.
